**Safety
Alert**

November 2006

"TAGGING A WELL"

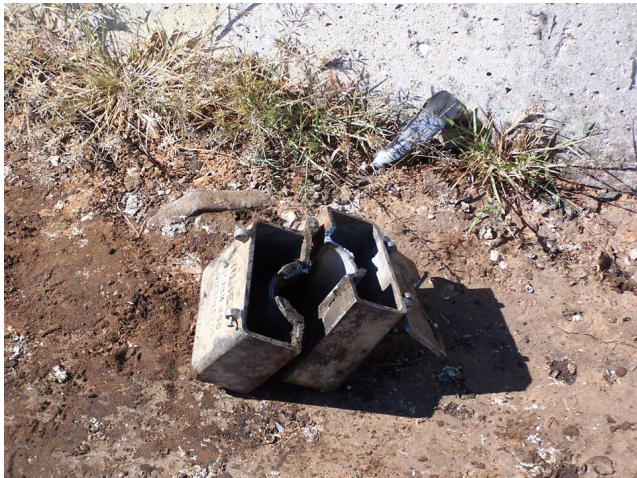
Lubricator Box that failed causing the rod string to fall.

- One of the two lubricator boxes failed causing the rod string to fall. Lubricator boxes are designed for polish rod lubrication, as lube oil reservoirs only, and are not designed to withstand a load.
- The contract employee had positioned his left hand between the top rod clamp and the load cell.

- Lubricator boxes and other similar pieces of equipment that do not have a documented load rating shall never be used for supporting the weight of a rod string. The proper equipment to be used is a manufactured rod stand, such as the Wamco Polished Rod Suitcase or a rod stand that is designed in accordance with generally accepted industry practices, has a documented load rating and a load test certification.
- Even though pinch points is a line item on pre-job tailgate safety meetings forms, all JSAs should address the placement of an employee's hands.

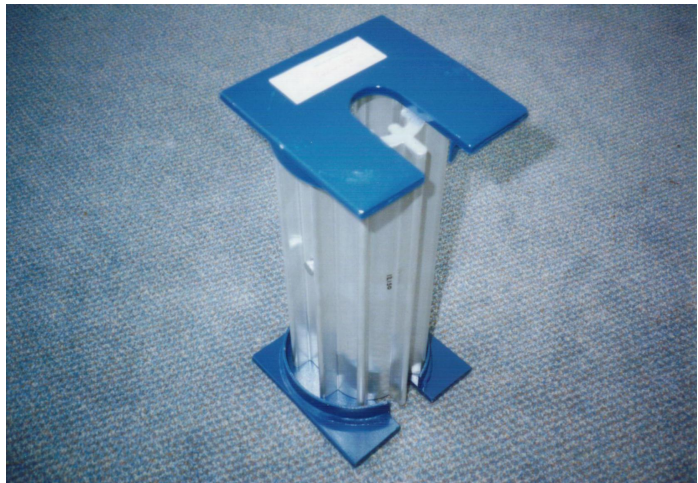
Wamco Suitcase –manufactured rod stand.
